COOS SOIL & WATER CONSERVATION DISTRICT

2020 Annual Report

Offfield Creek Riparian Enhancement Project

Trillium Stable Water Quality Improvement Project

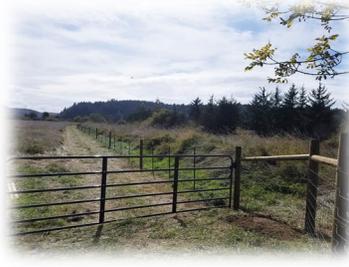
Riparian fencing to exclude livestock from streams and protect riparian vegetation.

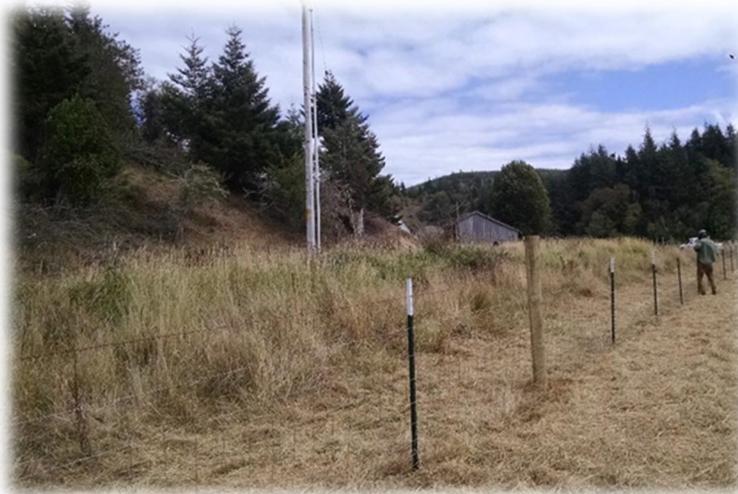
Figure 1. (left) Pre-Project Photo from August, 2016, shows the riparian condition pre-project. This photo was taken during fence construction. The vegetation consisted of primarily reed canary grass and Himalayan blackberry. Some of the overhanging grasses provided a little shade to the creek, but there was no woody tree or shrub component.

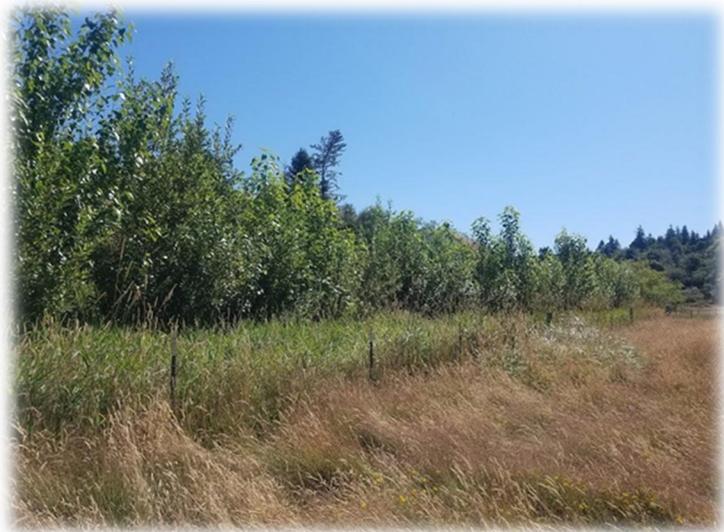
Figure 2. (Right) This photo, taken from roughly the same angle in July 2020, shows significant improvement in the riparian community after four years post-fencing and planting.

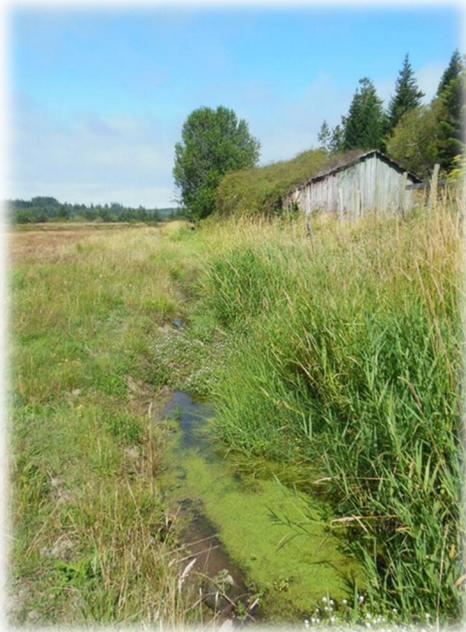
Figure 3. Pre-Project view of Offield Creek riparian condition (7/29/2016)

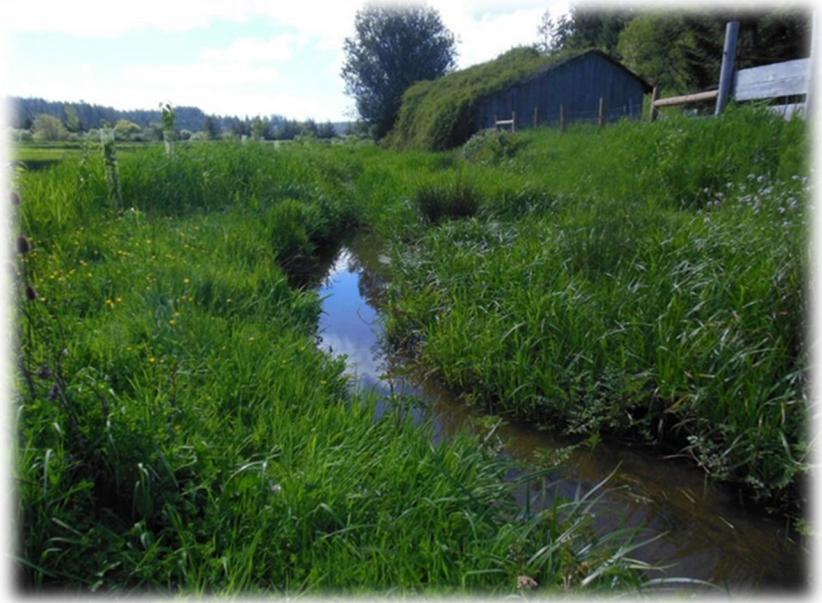
Figure 4. Photo taken at approximately 1-year post-implementation (15 months after planting). Planted riparian vegetation is entering its second growing season.

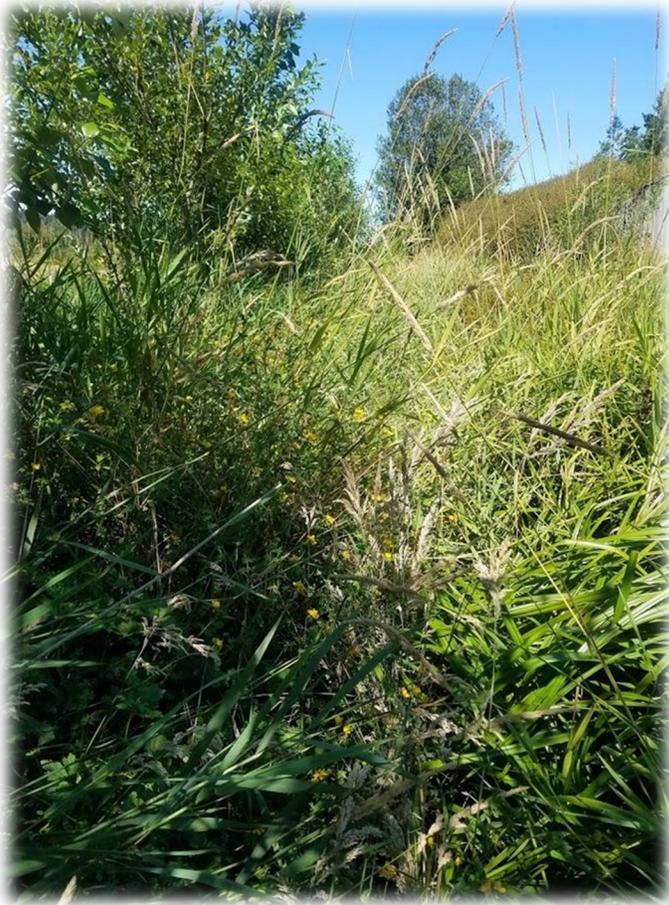
Figure 5. (left) The stream is now mostly shaded by overhanging grass and herbaceous vegetation, and the cottonwoods continue to grow and are already providing some shade. We hope that as the cottonwoods and willows continue to grow and shade the stream, they will reduce the amount of reed canary growing in and around the channel. Riparian plantings are in their fourth season of growth. Approx. 40 months post-planting. (7/20/20)

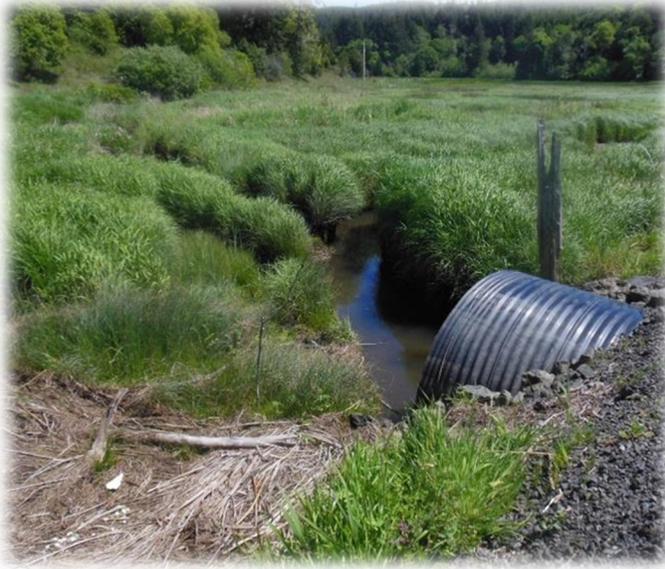
Figure 6. (left) This project was the site of a tide gate removal and culvert upgrade initiated by the County Road Department in 2016-17. Since installation of a larger pipe, the channel has begun flushing sediments and carving a more defined network in the lower portion of the pasture. This photo shows the new culvert and salt marsh tidal habitat post-fencing. (05/2018)

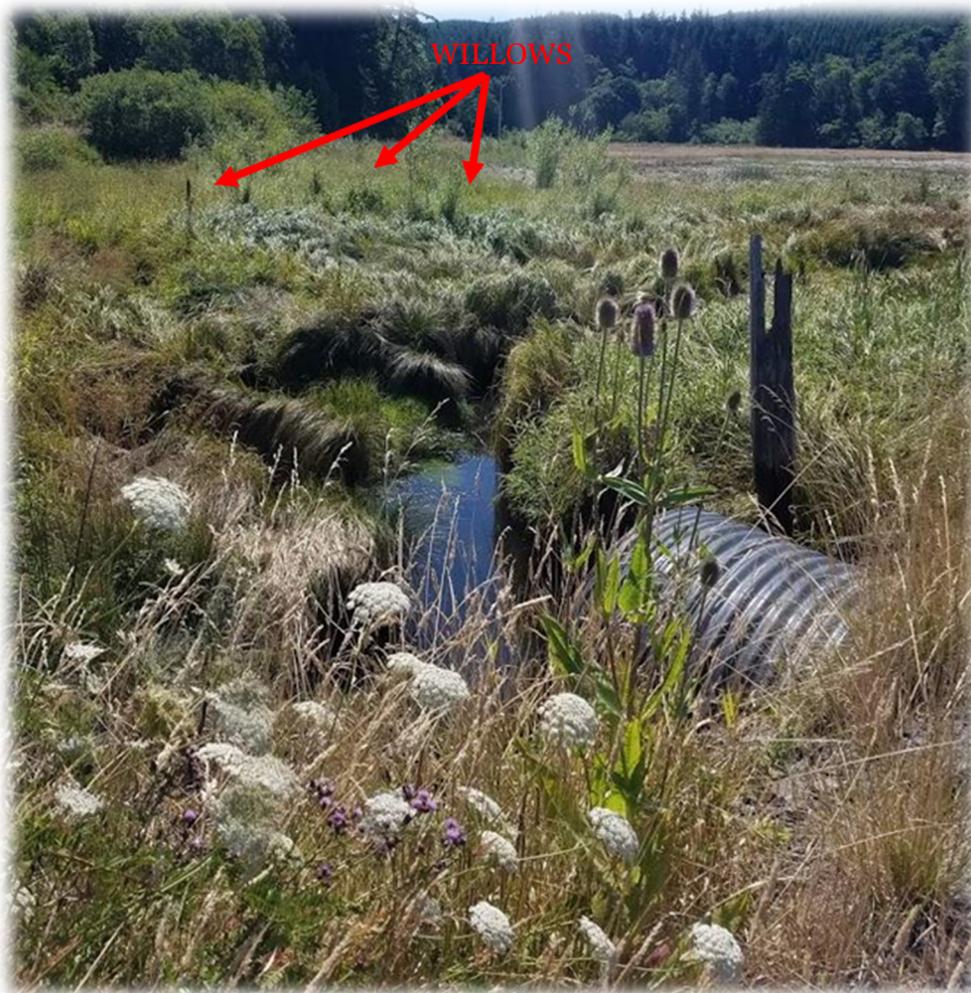
Figure 7. Culvert and salt marsh tidal habitat after 2 years of fencing. Willows planted in 2017 are approximately 5-6' tall. Trees planted in the portion of the project area are growing slightly slower due to the saltwater influence on incoming tides (7/20/2020)

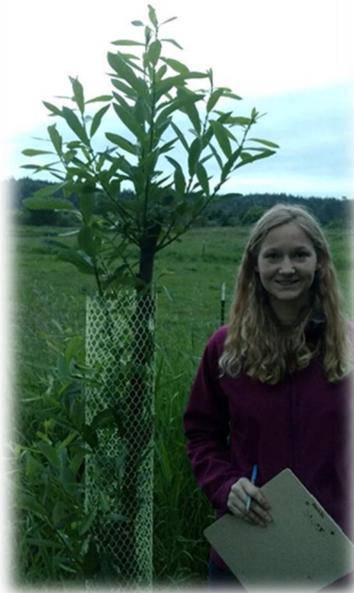
Figure 8.
Cottonwoods
at 10 months
post planting.
Model is 5'8".
(12/04/2017)

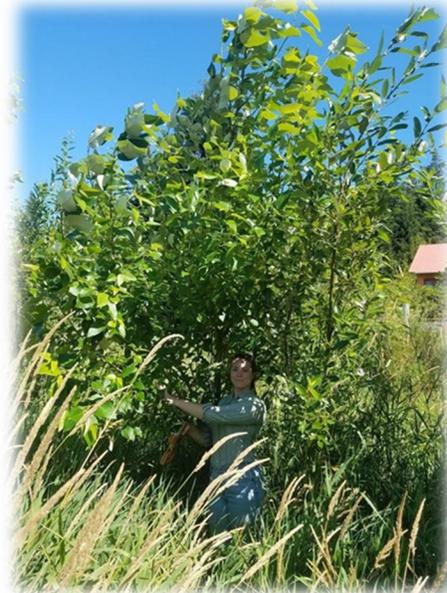
Figure 9.
Cottonwoods
40 months
post-
planting.
Model is
5'3".

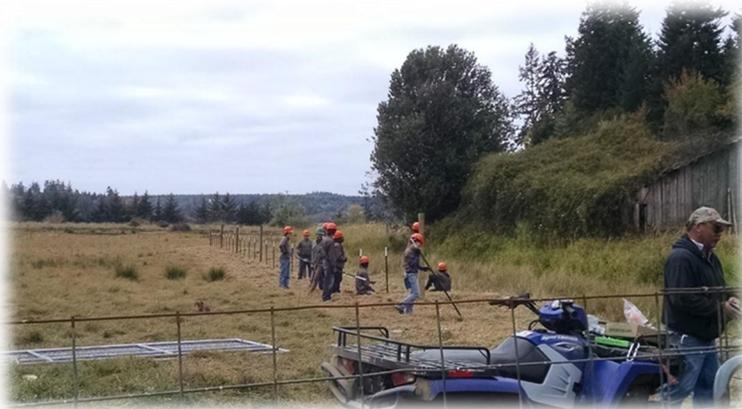
Figure 10. (left) Photo taken during fence construction in 2016 shows the original riparian condition of Offfield Creek on 8/29/2016.

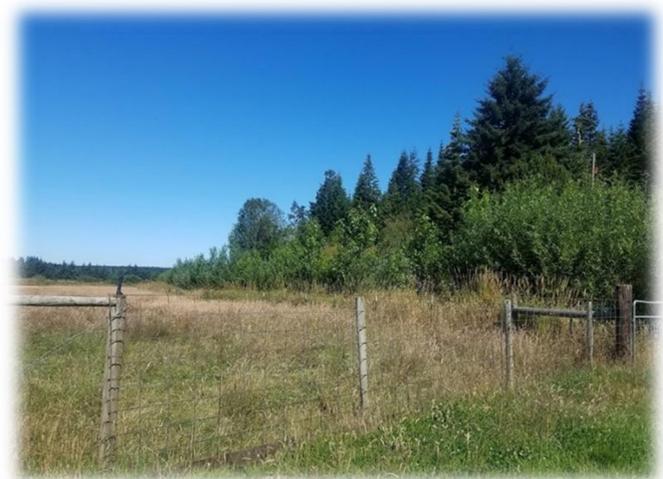
Figure 11. (right) A row of willows and Cottonwoods now line the stream (7/20/2020)

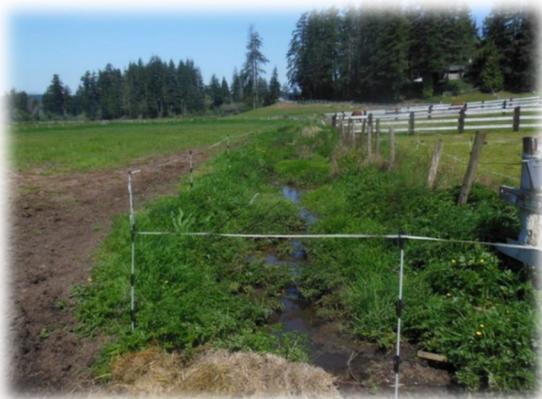
Figure 12. (left) Landowner voluntarily fenced off the drainage channel running alongside his pasture (and out into the Isthmus Slough) and allowed herbaceous vegetation to establish naturally. (8/08/2018)

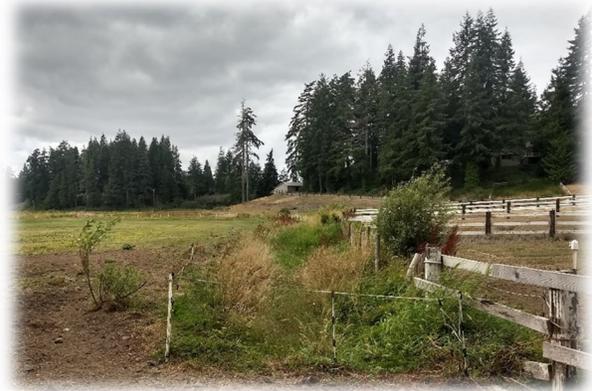
Figure 13. (right) The voluntary fence is still functioning and keeping livestock out of the drainage channel. This has allowed for vegetation to naturally re-establish and is now shading the channel. (8/05/2020)

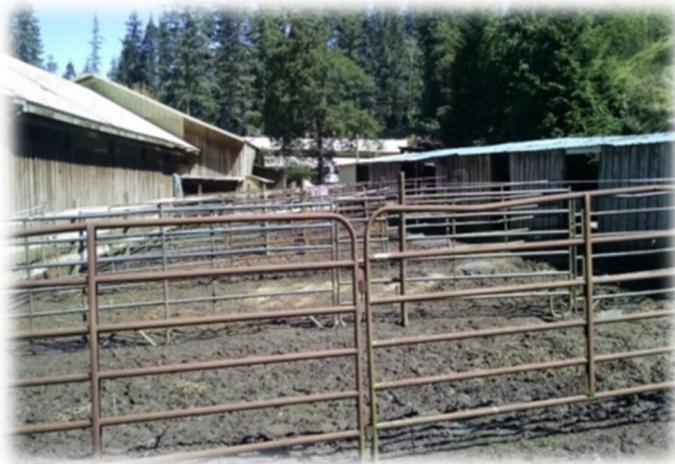
Figure 14. (left) Paddocks between barn and stables. Before: Highly concentrated mud/manure runoff area. (4/14/2017)

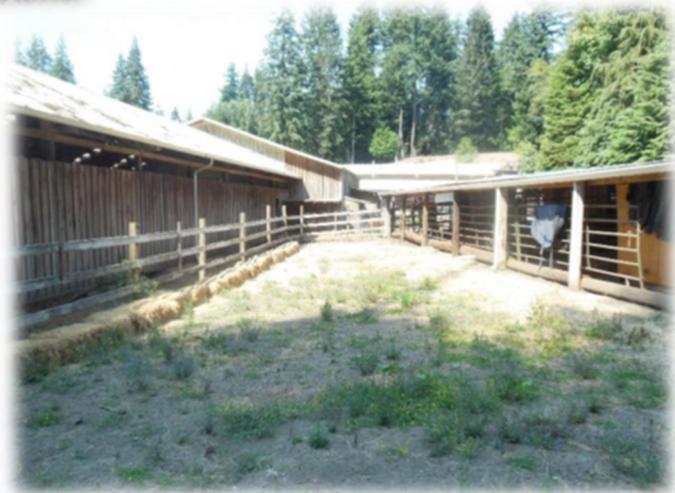
Figure 15. (right) Paddocks between barn and stables. After: Paddocks reduced and covered with roofing. Vegetation slow to grow due to compaction and poultry eating grass seeds. (8/08/2018)

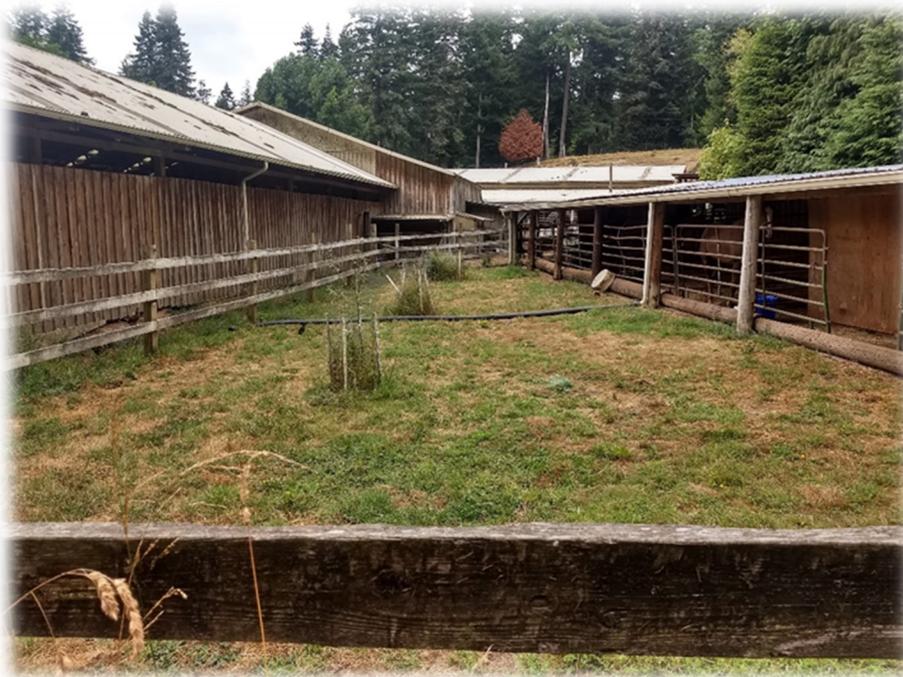
Figure 16. (left) Paddocks between barn and stables 2 years later: Roofing on paddocks still functional, vegetation is now established in between barn and paddocks. Gutters on paddocks are funneling water to the drainage area. (8/05/2020)

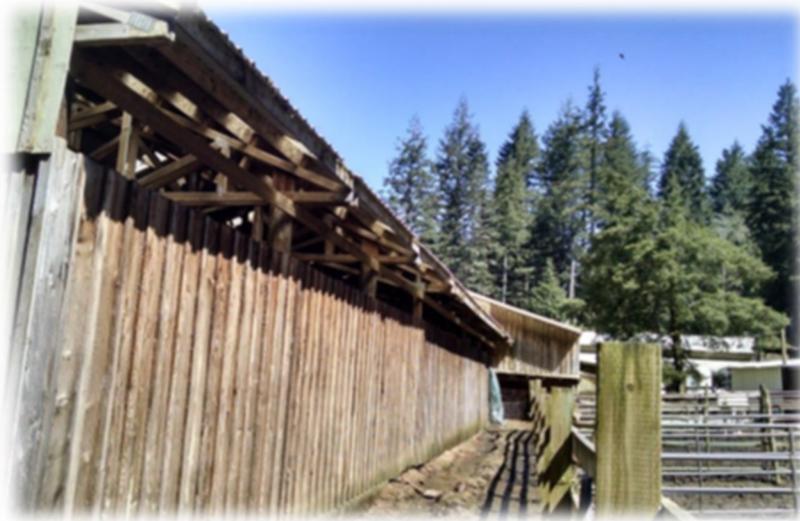
Figure 17. (left) Before: Main Barn, no gutters (6/14/2017)

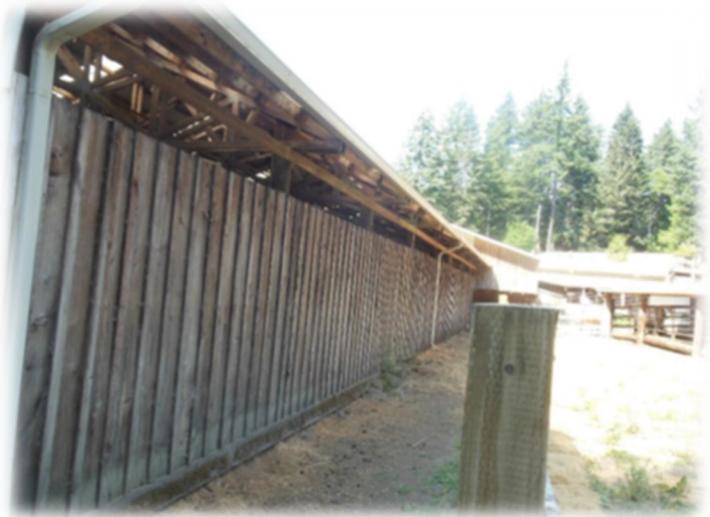
Figure 18. (right) After: Main Barn, gutters installed. (6/14/2018)

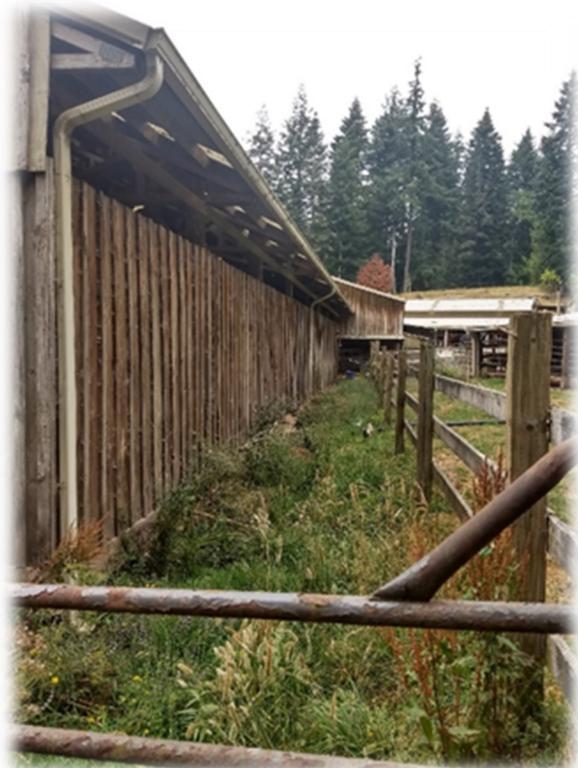
Figure 19. (left) 2 Years later: Main Barn gutters and adjacent drainage, vegetation has established in the area and is serving as a filtration system. (8/05/2020)

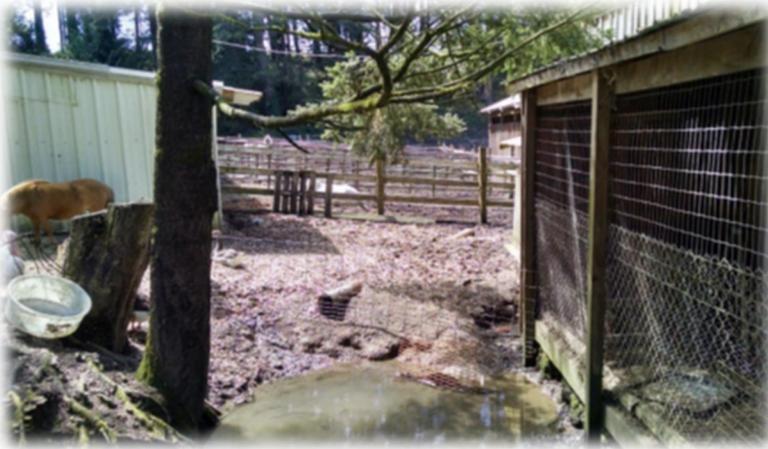
Figure 20. (left) Main Barn, adjacent drainage (facing south). Before project: water flows directly through the stable yard and alongside main barn (6/14/2017)

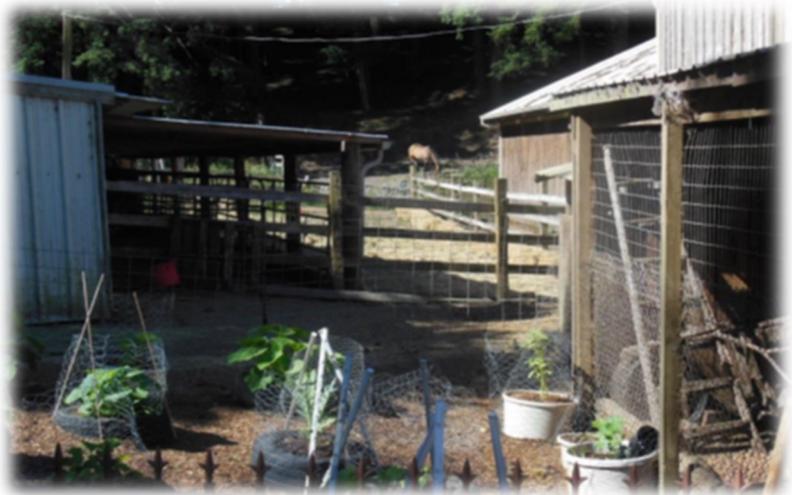
Figure 21. (right) Main Barn, adjacent drainage (facing south). After project: culvert has been replaced and installed so that there is no longer any above-ground flow through the stable yard, vegetable garden planted (7/03/2018)

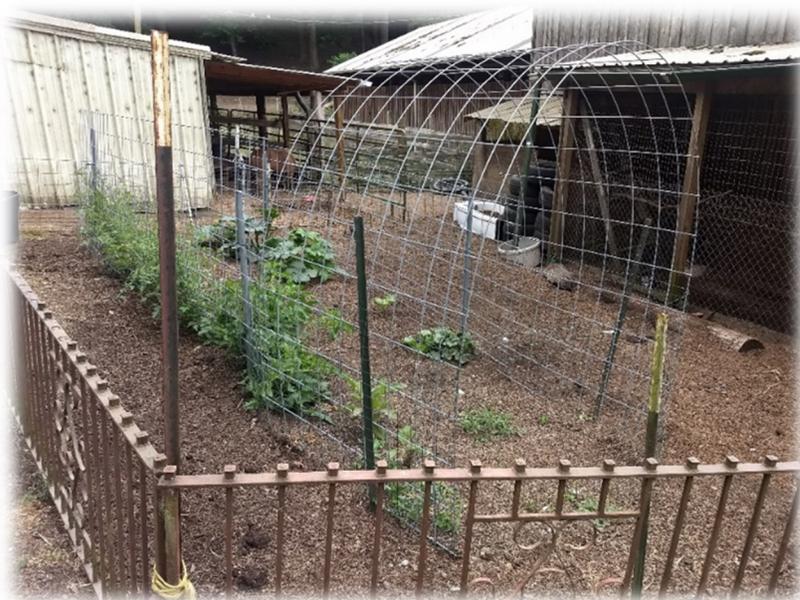
Figure 22. Main barn, adjacent drainage (facing south). 2 Years Later: Culvert is functional and vegetable garden is growing. (8/05/2020)

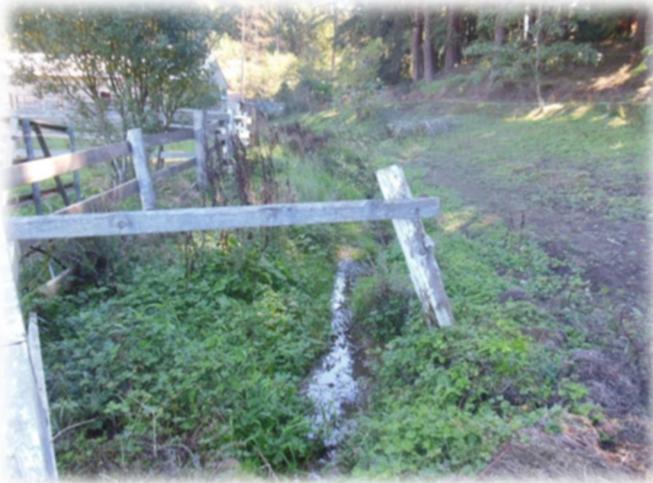
Figure 23. Hillside pasture which was being used as an exercise area (now retired), vegetation beginning to grow along the tributary. (10/03/2017)

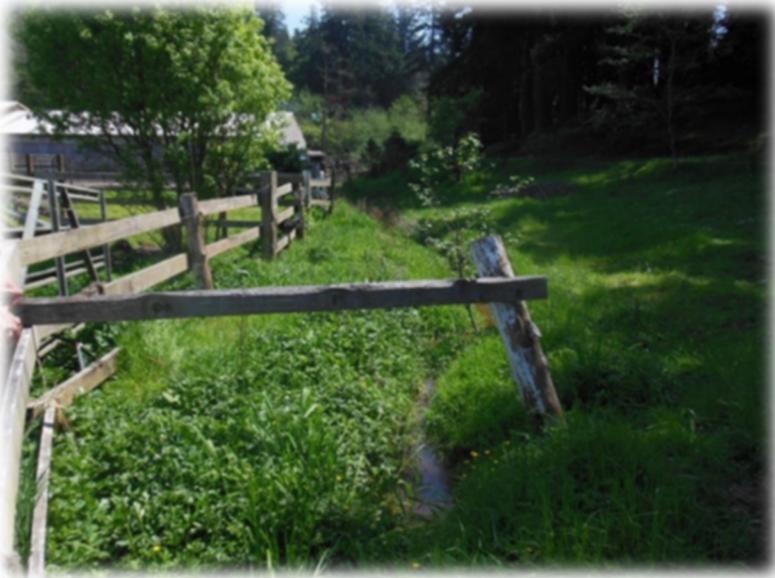
Figure 24. Improvement of the small hillside pasture retired to allow grass growth, vegetation is growing up along the tributary stream. (3/25/2018)

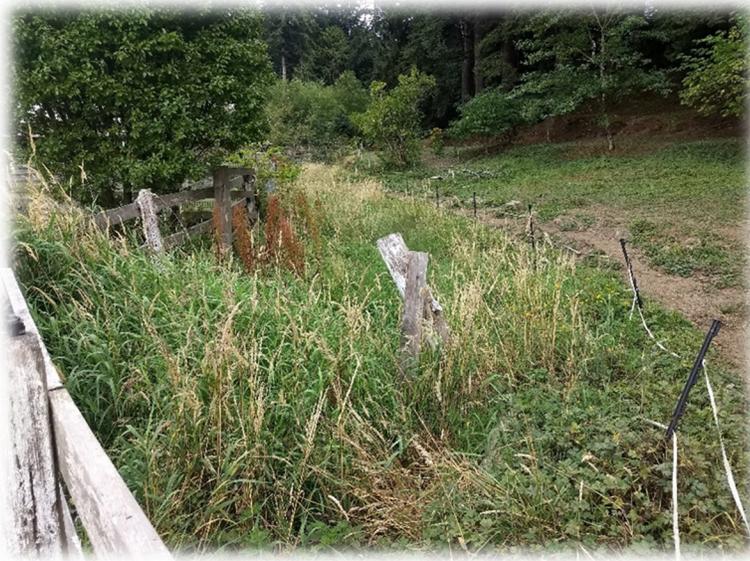
Figure 25. Hillside pasture (being used as a paddock area for 1 pony), herbaceous vegetation has grown up and taller grasses are now shading the tributary stream. Fencing has also been implemented by landowner in order to ensure livestock do not access the stream. (8/05/2020)

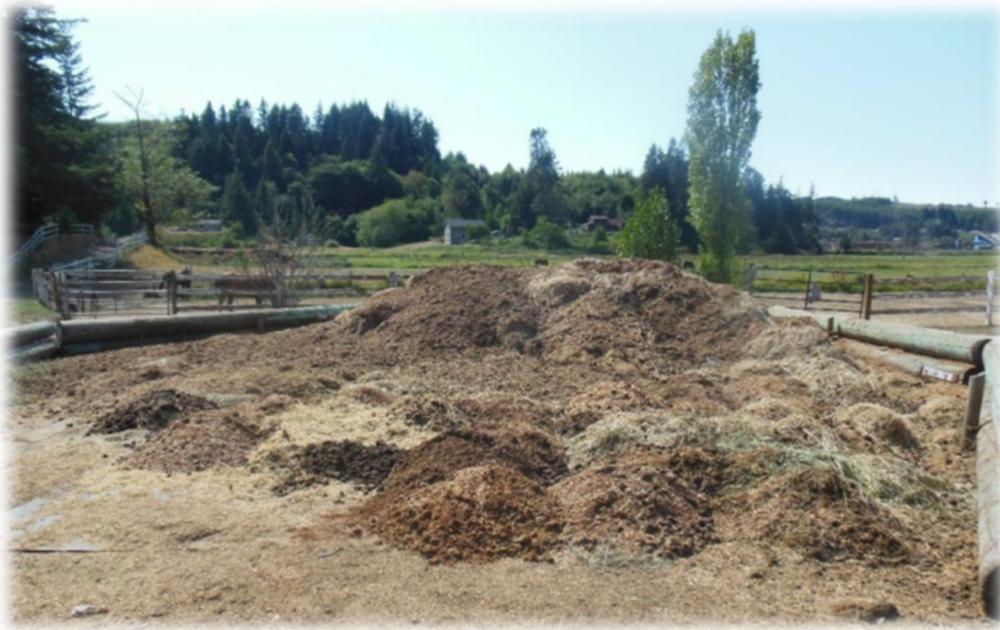
Figure 26. New location of winter-storage manure pile, on a hardened gravel surface overlaid with rubber small mats, and with telephone pole curbs to further prevent runoff in direction of stream. (8/08/2018)

The hardened site for the manure pile is holding up well; the gravel surface, rubber mats, and telephone pole curbs are all in good condition and preventing manure from getting into the streams (*Figure 32*). The small hillside pasture is in better condition than originally observed. More herbaceous vegetation has established along the stream and is effectively serving to shade the small channel. Vegetation buffers along the streams are all functioning well; the landowner has placed fences along all the streams and drainage channels onsite to help keep the livestock out of the waterways. This is helping to allow for vegetation to establish and shade the channels, as well as provide a vegetative filter for runoff.

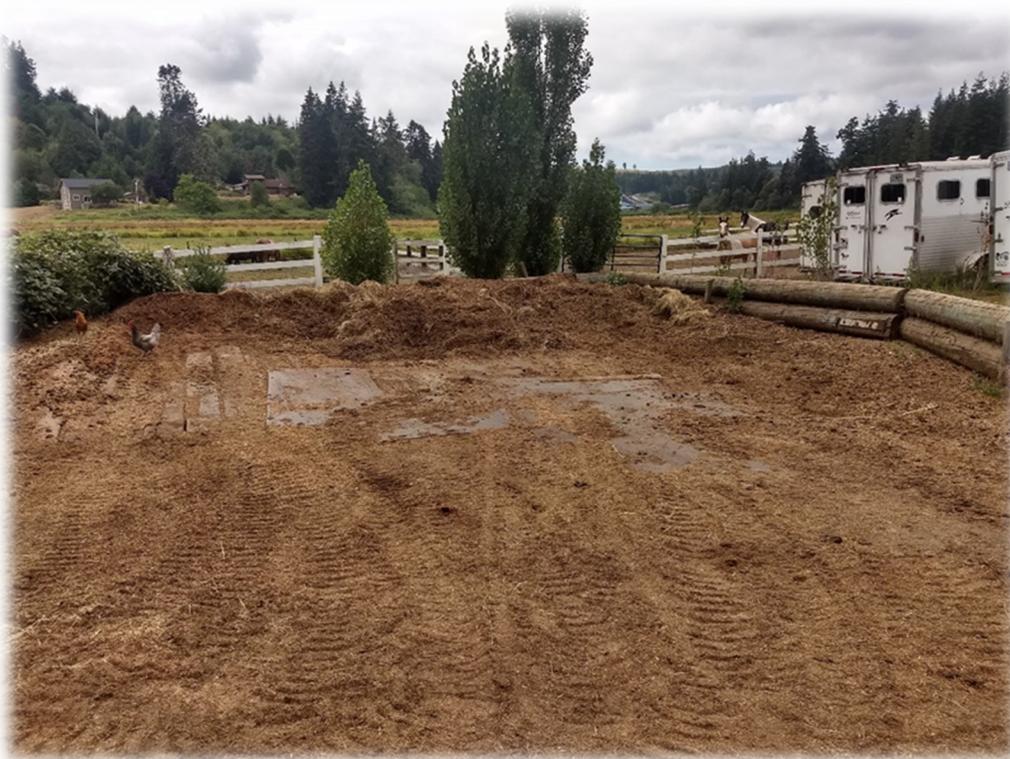
Figure 27. New location of winter storage manure pile, on hardened gravel surface, overlaid with rubber mats and telephone pole curbs. 2 years later: still preventing runoff in direction of stream. (8/05/2020)

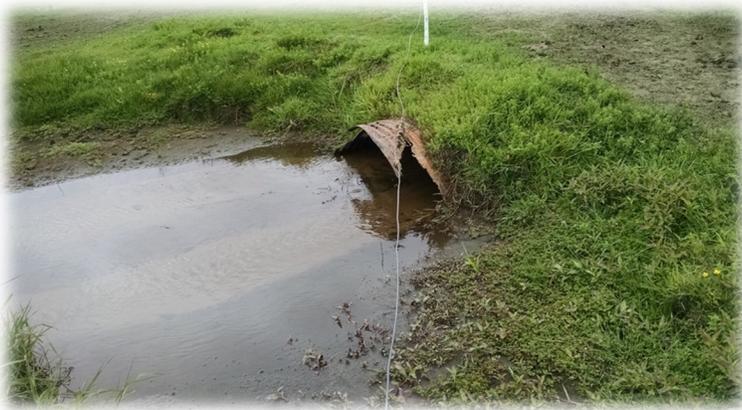
Figure 28. Main Adams Creek Channel; pipe outlet (8/25/16)

The Adams Creek Culvert Replacement is in good standing. The Adams Creek Watershed is a tributary to the South Tenmile Lake in Lakeside, Oregon. In 2016, the landowner reached out to Coos SWCD regarding the main culvert onsite was failing due to age (Figures 1-2). The culvert was also causing hydrologic dysfunction due to being undersized. This created a "pinch point" of the channel, obstructing natural flow and causing the stream to deposit sediment around the inlet and inside of the pipe. As the pipe began to fill with sediments, reducing its aperture even further, the stream would overflow into the adjacent pastures and form new channels around the obstruction.

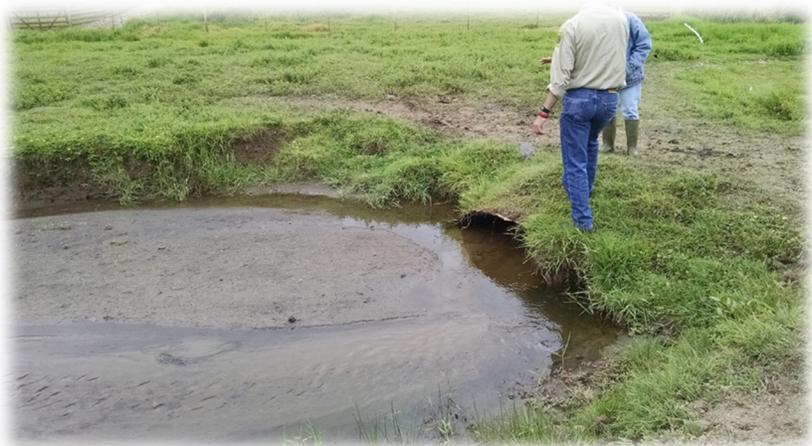
Figure 29. Main Adams Creek Channel; pipe inlet (8/25/16)

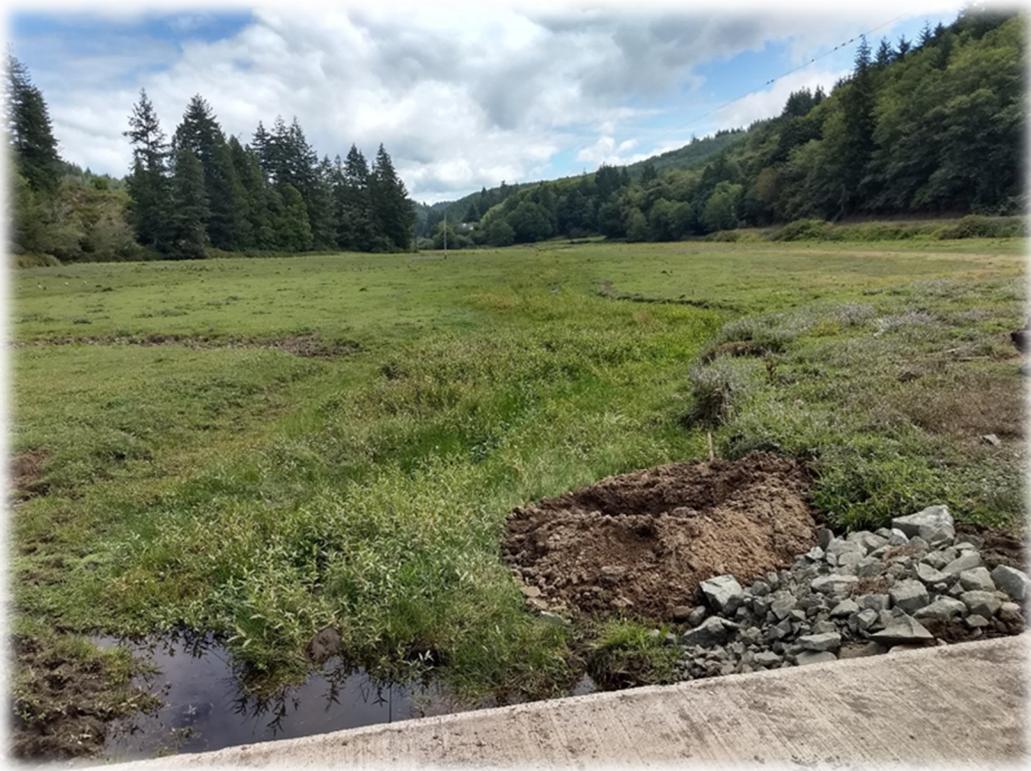
Figure 30. Adams Creek culvert inlet (facing upstream) 8/27/2018 just after bridge installation.

Through Small Grant Project 04-18-006, the failing culvert was replaced with a 20' long by 16' wide engineered concrete slab bridge (designed to meet fish passage and to properly accommodate the Active Channel Width). The bridge appears sound and is allowing water and sediments to pass, effectively relieving the "pinch point" in the channel and restoring a more natural hydraulic function to the site. The bridge also allows the landowner access to the pasture on the other side of the stream, so they can manage their livestock grazing activities.

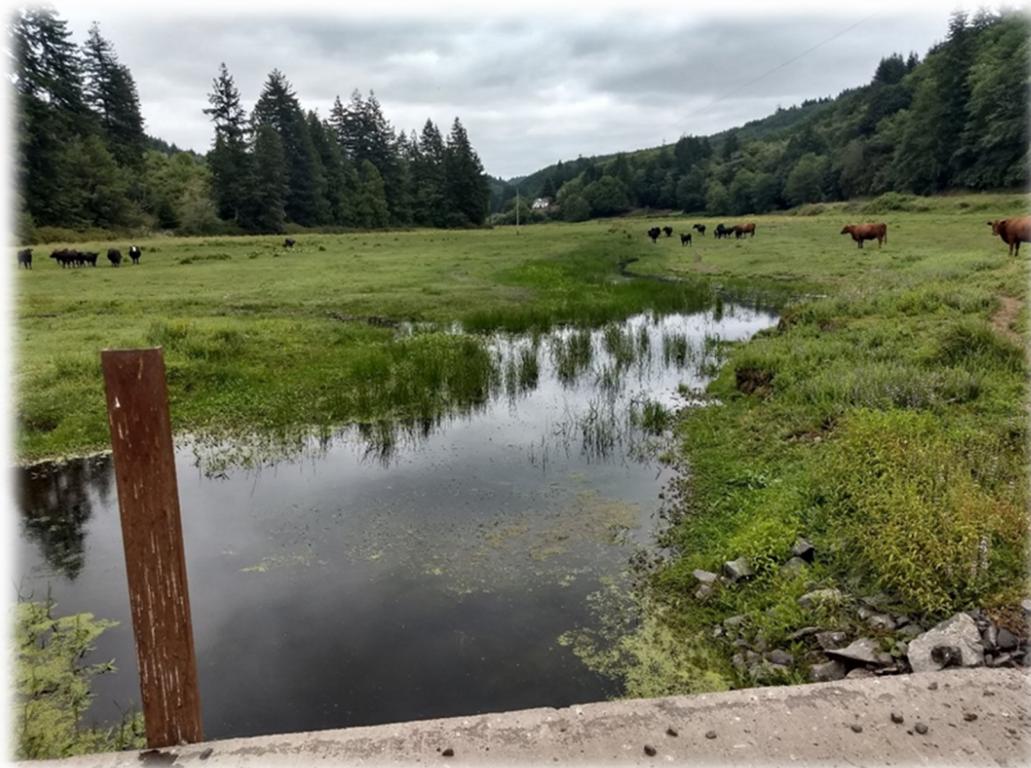
Figure 31. Adams Creek main Channel inlet (looking upstream). After 2 years after Bridge installation (8/05/2020)

Although the change is subtle, the channel does appear to have begun to flush itself out more and is becoming slightly more defined (Figures 3 - 8). Overall, the installment of this bridge has dealt with the hydraulic issues on site that were created by the failing culvert, and two years later it is still standing and performing properly (Figures 9-11). This site would benefit even further from riparian plantings and exclusion fencing to help keep cattle out of the channel and to shade the stream. The channel seems to be improving conditions, as there were many juvenile fish, frogs, and macroinvertebrates present in the stream, as of August 2020 (Figure 12). This bridge should continue to allow for the channel to become more defined throughout the years.

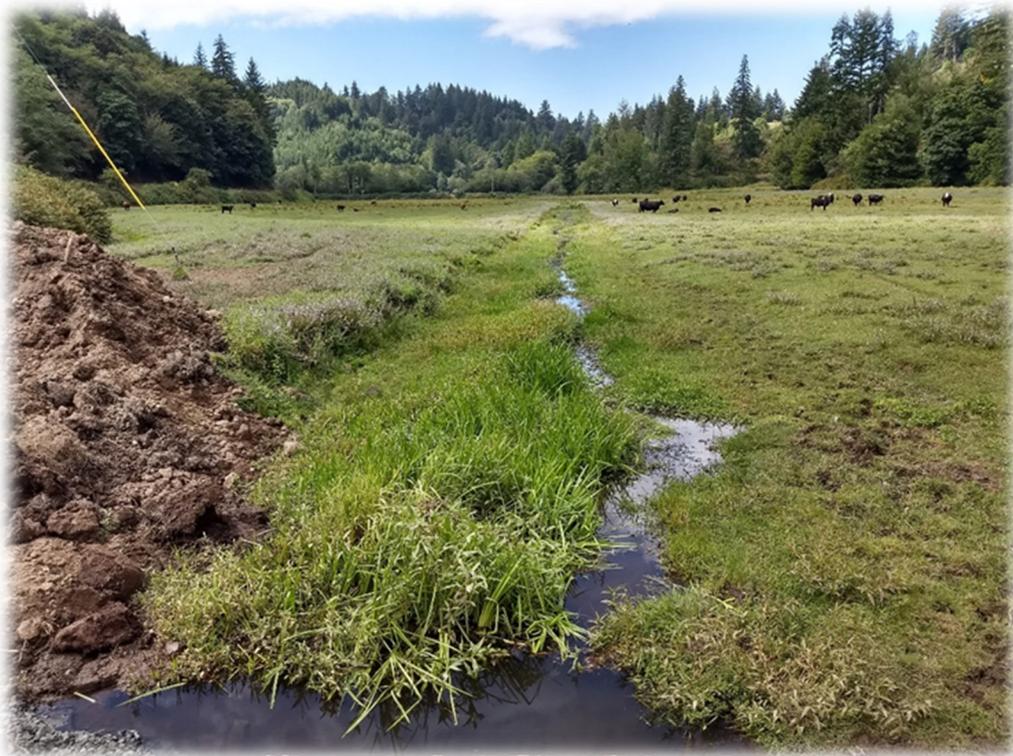
Figure 32. Adams Creek culvert outlet (facing downstream) just after bridge installation (8/27/2018).

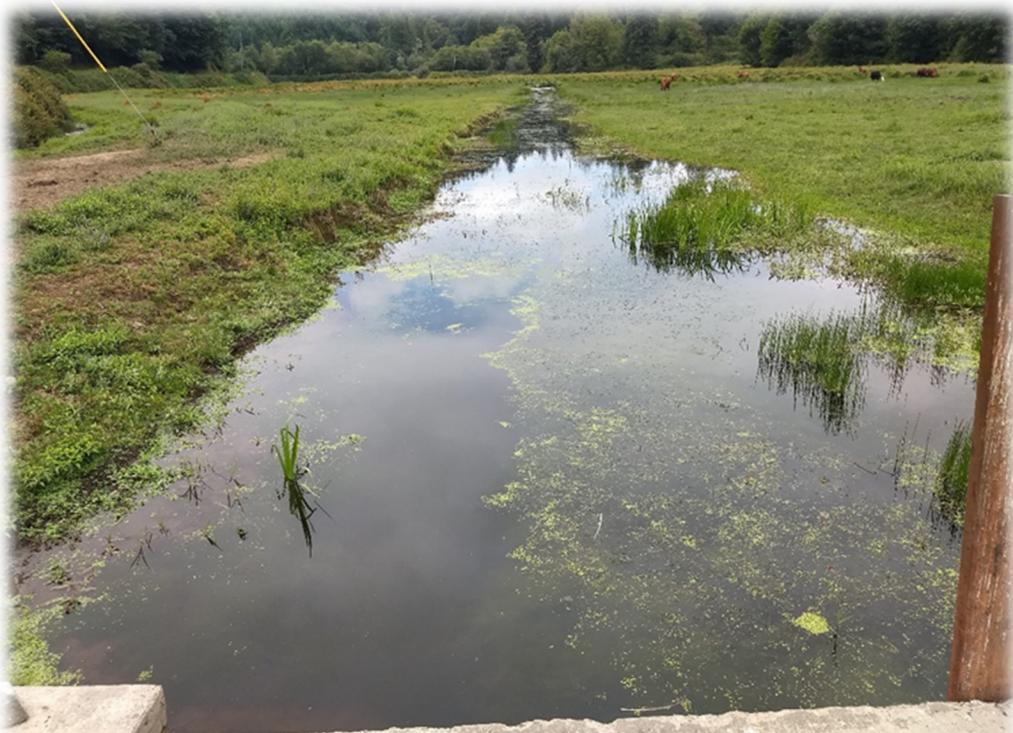
Figure 33. Adams Creek Main Channel inlet, 2 years after bridge installation (8/25/2020). Water levels may be higher this year, however the channel has clearly flushed some of the sediments and there is less vegetation in the channel. This indicates improved movement and sediment exportation.

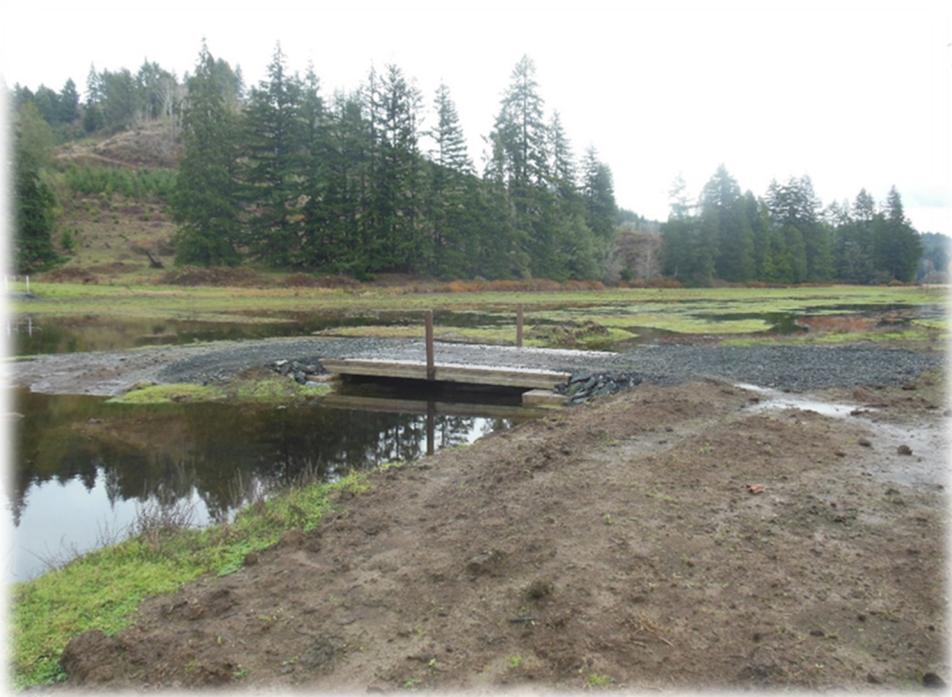
Figure 34. Winter high-flows following bridge installation. (11/29/2018)

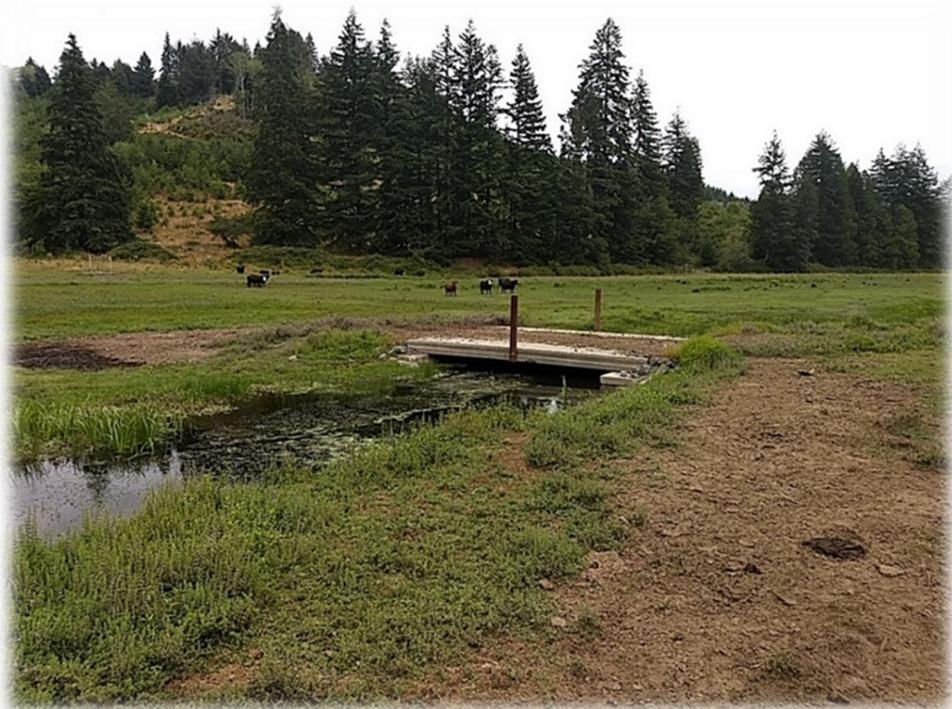
Figure 35. Two years after bridge implementation, crossing is still in good standing and the channel is becoming more defined. (8/05/2020)

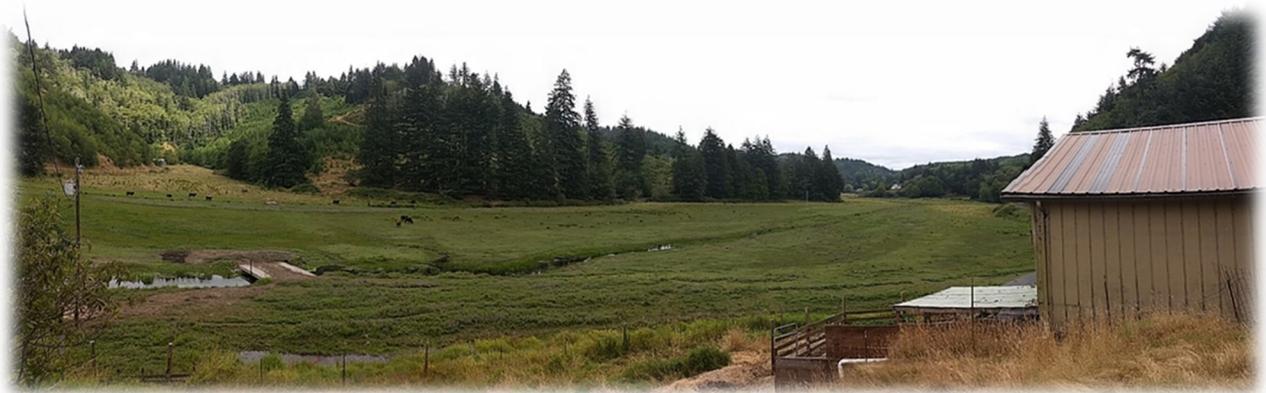
Figure 36. Main Adams Creek channel; facing north, channel is flushing sediments better and gradually becoming more defined two years after culvert replacement. (8/05/2020)

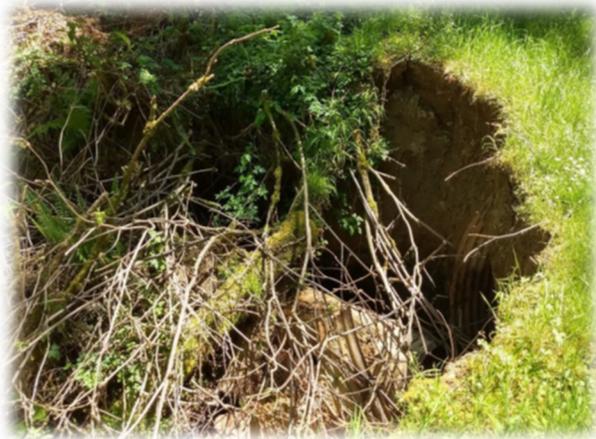
The MacWhorter property is located on Johnson Creek, south of Bandon. In late 2018-early 2019, the culvert of the MacWhorter property began to deteriorate rapidly, resulting in the partial collapse of the stream crossing. The culvert degraded to a level where rust gaps in the bottom allowed for streamflow to run partially through the culvert and partially under the pipe. This resulted in flows being directed in multiple pathways and ultimately creating velocity issues within the stream. If this problem were not addressed, the collapse of the culvert would threaten to impair both the landowner’s and fish access to the upper reaches of Johnson Creek. Additionally, through continued erosion and collapse of the pipe would contribute a substantial sediment input to the stream effecting fish habitat and instream flow. To address the problem the MacWhorter’s are working with Coos SWCD to replace the failing culvert with a new stream crossing bridge. This will result in alleviating the high potential of complete road prism failure and restore full fish access to the creek. While the MacWhorters may have been able to handle this problem themselves, they made the decision to reach out to the Coos SWCD to make sure that the new bridge was designed properly to ensure all environmental benefits that could be received, would be.

Forest Access road erosion due to collapsed culvert- Pipe Outlet (5/09/2019)

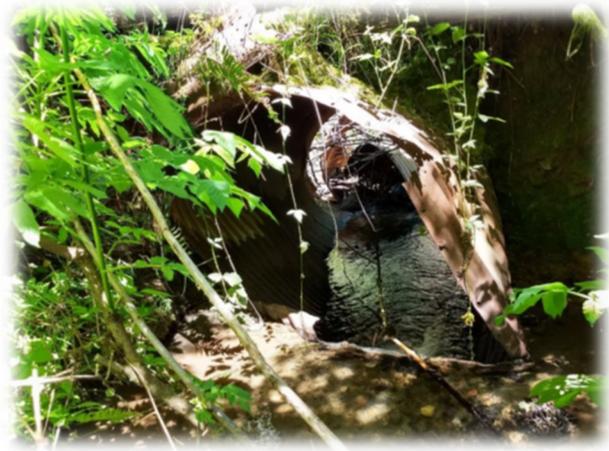
MacWhorter pipe inlet. (5/09/201)
