City of Myrtle Point Drinking Source Water Protection Plan

Randolph Slough Riparian Enhancement Project

Coos-Coquille Comprehensive Tidegate Outreach and Engagement Project

Vincent Fish Passage Project

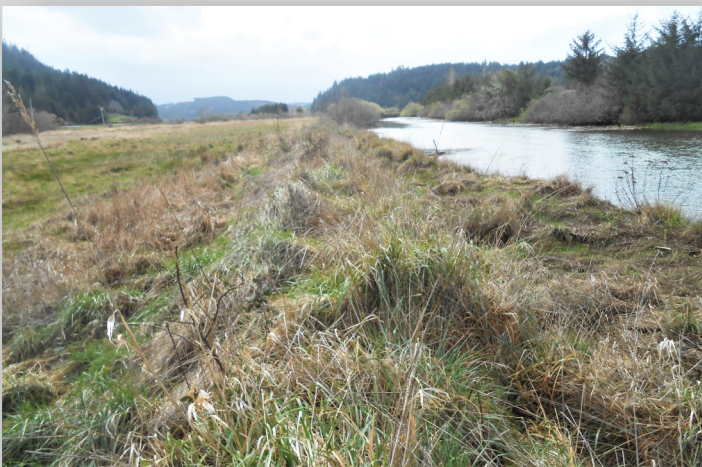
BEFORE

This project funded 1020 ft. total of woven wire fencing, in order to completely exclude livestock from the riparian area of Randolph Slough. Along with exclusion fencing, a riparian planting plan was implemented for approximately 0.8 acres near the fenced pasture, plus an additional narrow strip of bank extending about 60 yards upstream of the pasture, between the county road and Randolph Slough.

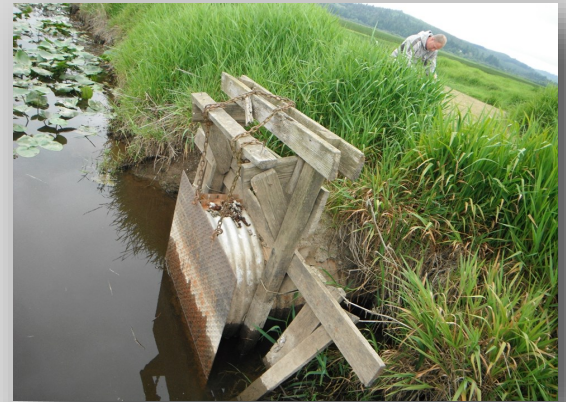
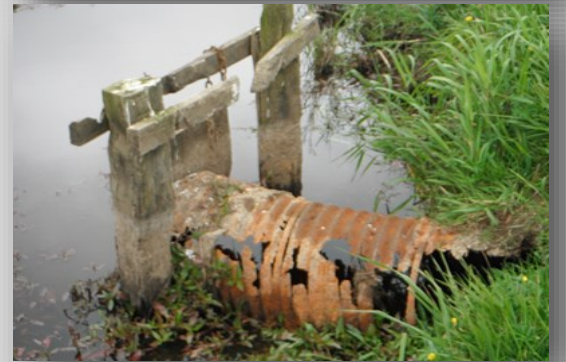
Tidegates – what are they and how do they function?

Tide gates are structures that control the flow of water during high and low tides, and many are located throughout the lowlands of the Coquille and Coos Basins. Tidegates close during the period of high tide to protect farms, structures, and roads from inundation. When the tides recede, the gates open to allow for drainage.

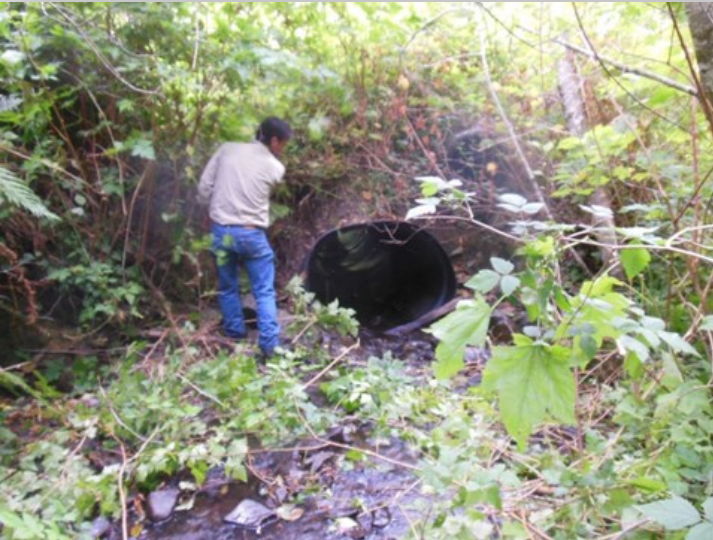
BEFORE

The primary focus of this project was replacement of a perched 48" culvert located at stream mile 3.4 of South Twomile Creek. The road over this segment of stream serves as the primary route for livestock movements into the hill pasture lands upstream of that location. Livestock are dispersed into the upper South Two-mile lands using this route and gathered as well.

The Active Channel Width of the stream for this reach averaged 8.7ft. Though the culvert was functional, the landowner, Mitch. Vincent, was concerned with fish passage through the culvert as it was undersized by ~2.5x, had a slope >6%, and an outfall onto boulders without a jump pool. South Twomile Creek is considered fish bearing through the reach where the perched culvert is located. There is 1.35 miles of cutthroat habitat upstream of the perched culvert and 1.5 miles of coho habitat. The perched condition of the culvert resulted in complete blockage of anadromous and resident migratory fish movements up and through this segment of stream. OWEB small grant funds facilitated replacement of the pipe with an engineered active channel spanning bridge to enhance fish passage to the upper reaches of south Twomile Creek.

The primary issue was a perched 48" culvert located at stream mile 3.4 on South Two-mile Creek. Though the culvert was functional, the landowner, Mitch Vincent, was concerned with fish passage through the culvert as it was undersized by ~2.5x, had a slope >6%, and an outfall onto boulders without a jump pool. The road over this segment of stream serves as the primary route for livestock movements into the hill pasture lands upstream of that location. Livestock are dispersed into the upper South Two-mile lands using this route and gathered as well. Additionally, there is a rock pit located near the end of this road network and timber harvest is facilitated by the road.
